STM32WB55xx/STM32WB35Cx device errata

This document applies to the part numbers of STM32WB55xx/STM32WB35Cx devices and the device variants as stated in this page.

It gives a summary and a description of the device errata, with respect to the device datasheet and reference manual RM0434. Deviation of the real device behavior from the intended device behavior is considered to be a device limitation. Deviation of the description in the reference manual or the datasheet from the intended device behavior is considered to be a documentation erratum. The term “*errata*” applies both to limitations and documentation errata.

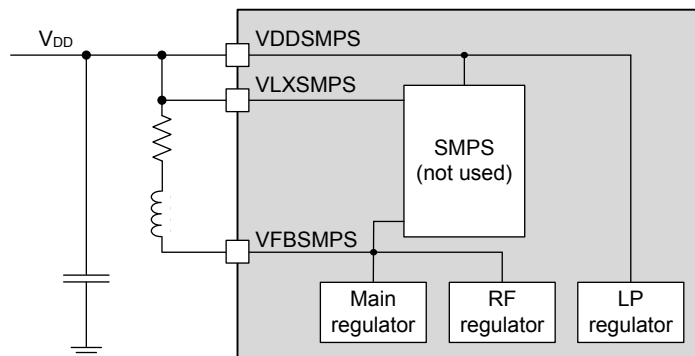
Figure 1. Workaround

The Hard Fault can be observed in case SYSCLK=HSE. Otherwise the risk is radio malfunction since clocked from HSE directly too.

The recommended inductor characteristics are the inductance 1.8 nH +/- 0.1 nH, self-resonance frequency of 6 Ghz +/-15 %, and rated current of 1000 mA. The resistor of 2.2 Ω recommended resistance must be dimensioned to dissipate 1 watt during 5 ns. Refer to [Minimal BOM for STM32WB Series microcontrollers \(AN5290\)](#) for more details.

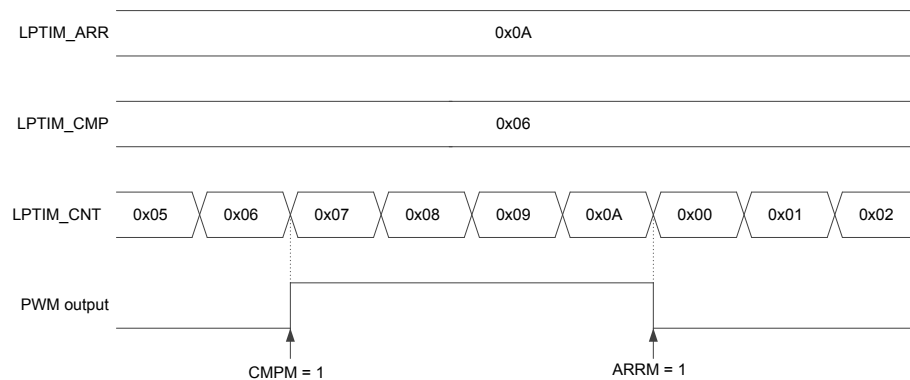
Consequently, it is not possible to generate PWM with a duty cycle of 0% or 100%.

The following waveform gives the example of PWM output mode and the effect of the delay:

Set the compare value to the desired value minus 1. For instance in order to generate a compare match when LPTIM_CNT = 0x08, set the compare value to 0x07.

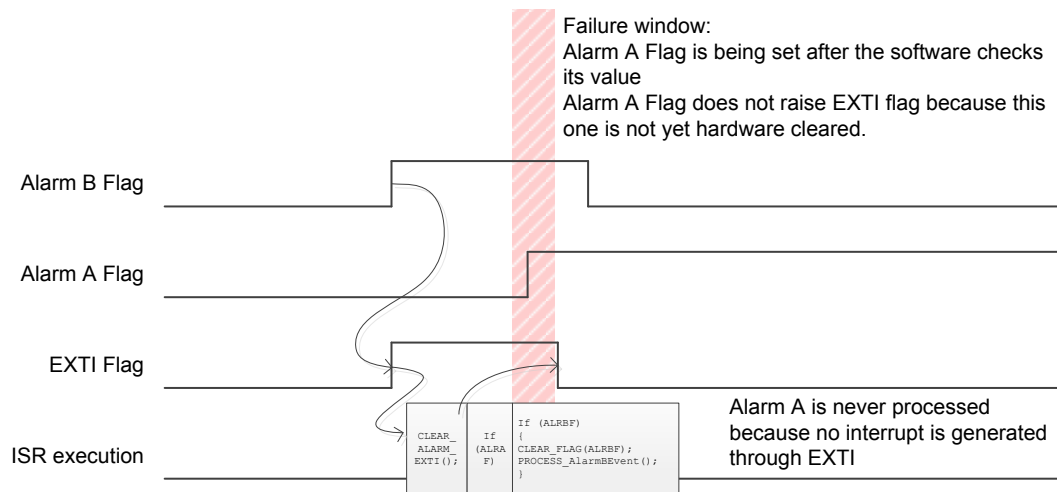
Figure 2. Masked RTC interrupt

The following code example and figure illustrate the failure mechanism: The Alarm A event is lost (fails to generate interrupt) as it occurs in the failure window, that is, after checking the Alarm A event flag but before the effective clear of the EXTI interrupt flag by hardware. The effective clear of the EXTI interrupt flag is delayed with respect to the software instruction to clear it.
